**Single Family House Fire**  
**May 4, 2011**  
**11221 Ashley Drive**  
**Box Area 5-13**

## Post Incident Analysis for 11221 Ashley Drive

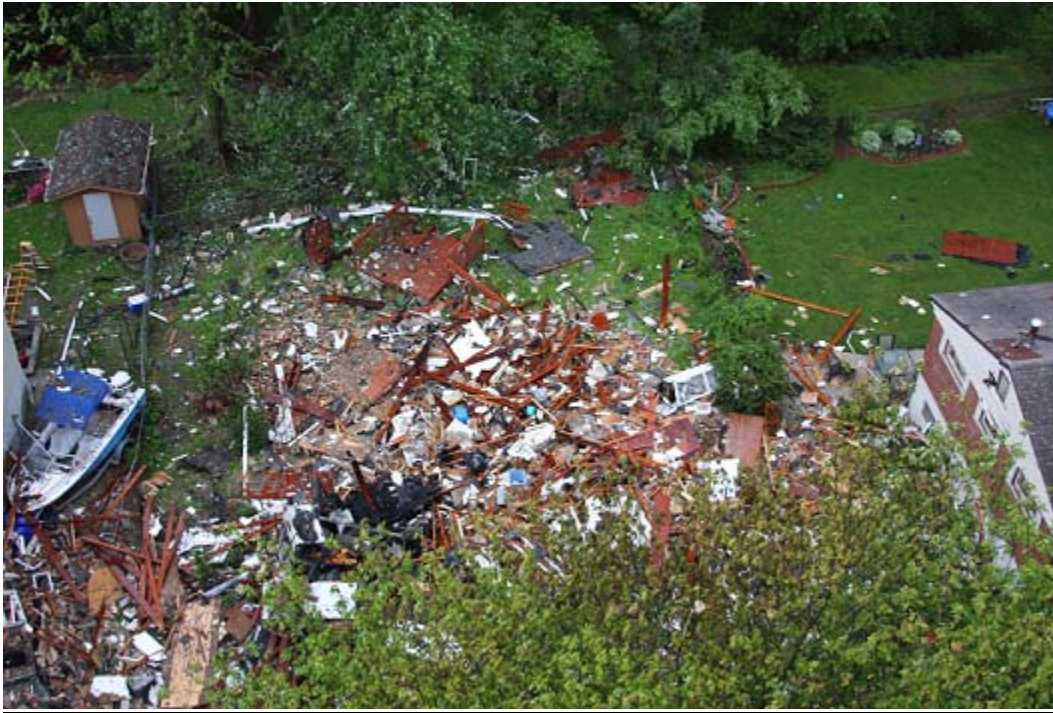
**Aerial View of Property/Debris Field**

- Single family home, middle of the block, with main entrance facing side Alpha.
- House was completely destroyed upon arrival of F/R units.
- Hydrants that could be accessed with straight lays were 11220 & 11206 Ashley Drive.
- Building construction of homes in the area is of brick and block Type 5 construction with wood frame interior walls, floors, and roof.
- House occupants had moved in four days prior to incident.
- Occupant had attempted to change gas powered clothes dryer in basement less than 24-hours prior to incident.

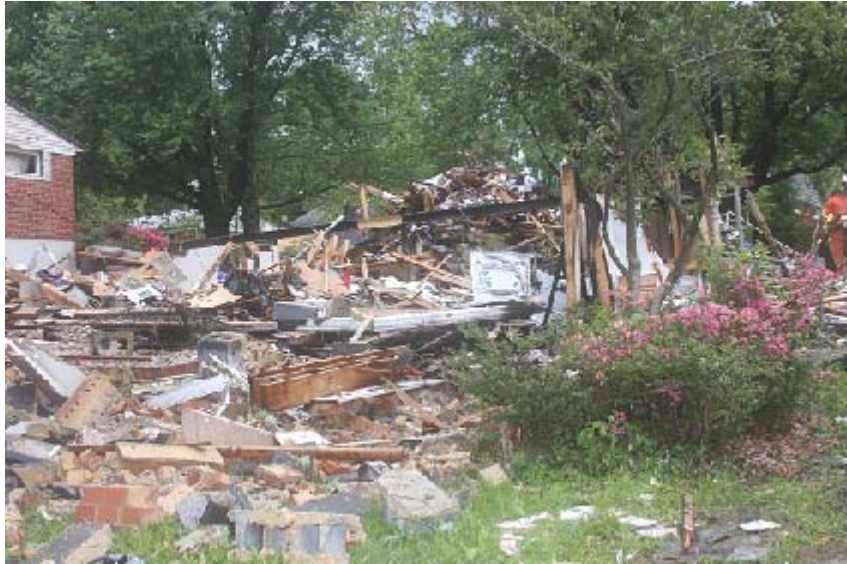
"Bravo/Charlie" Corner; Location of 1 Victim
